BICYCLE & PEDESTRIAN PLAN FOR GORHAM VILLAGE

FINAL REPORT
October 2017

PACTS
Portland Area Comprehensive
Transportation System

MILONE & MACBROOM

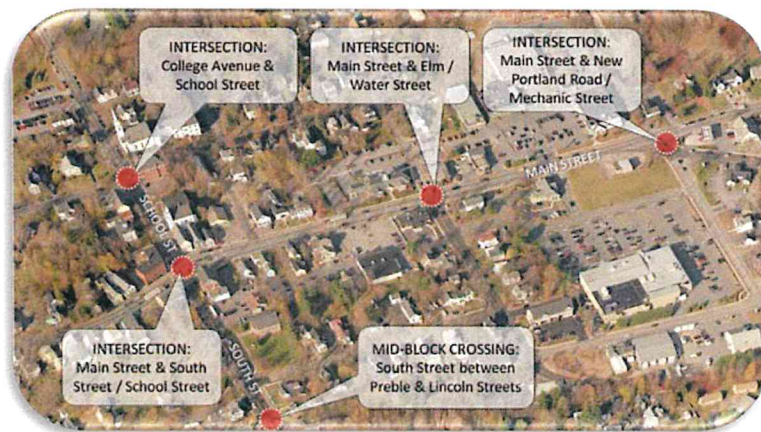
Figure 3.2 Focus area intersections and mid-block crossing.

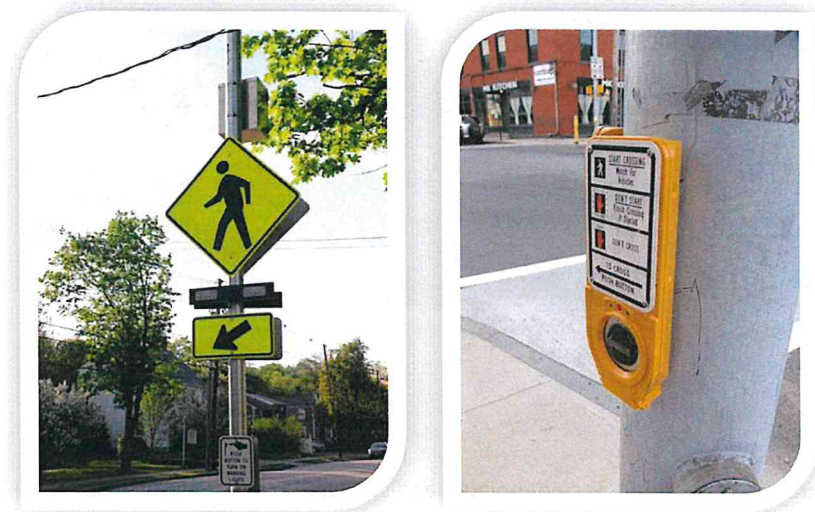
Figure 3.3 and 3.4 Existing mid-block crossing user-activated rapid flashing beacon and the pedestrian light activation button at the Main Street crossing.

Easterly on Main Street, there are no formalized opportunities for mid-block crossings for bicycles or pedestrians. In many cases, people cross a high-volume roadway in an unprotected fashion. Generally, throughout the study area there are no formalized bike lanes however, existing shoulder widths in portions of the study area are already wide enough to support bike lanes.

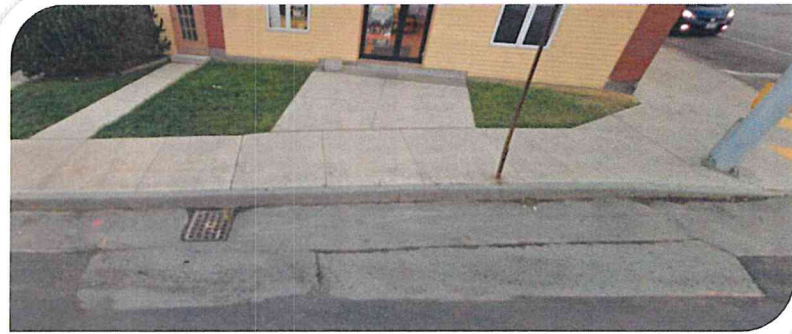
Figure 3.5: An example of a sidewalk that would receive an "Excellent" rating.

A rating of Good indicates the sidewalk is in a satisfactory condition. This would mean that there is some deterioration of the sidewalk that would differentiate its condition from an excellent sidewalk, but the condition does not appear to significantly impair any user from safely and efficiently operating on the sidewalk. An example of a Good sidewalk is shown below on South Street south of Lincoln Street. The sidewalk does not have significant cracking, spalling, gaps or rises between segments which would have a great impact on any user mobility. In this case, there is even a section of the sidewalk that has been repaired, though there is not a negative change in how the sidewalk can be used. Most sidewalks in Gorham can be rated as Good.

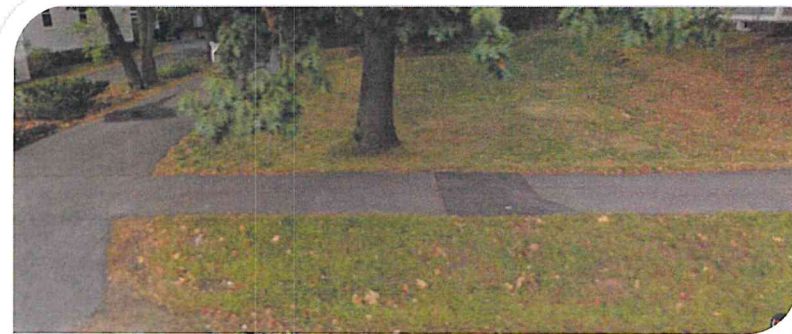
Figure 3.6: An example of a sidewalk that would receive a "Good" rating.

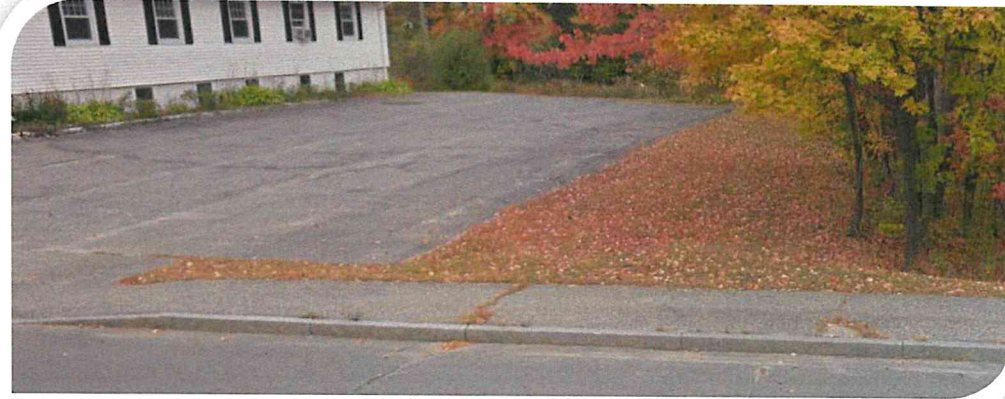
Figure 3.7: An example of a sidewalk that would receive a “Fair” rating.

A fair rating means there are notes issues with the condition of the sidewalk. This may mean a deterioration of the sidewalk such as cracking, spalling, gaps, or rises that may somewhat impact user mobility. An example of a fair sidewalk in Gorham would be a section on Main Street east of Libby Avenue. The sidewalk is now showing clear signs of deterioration. While the section may adequately allow most users to pass with ease, users with mobility issues may begin to have trouble traversing.

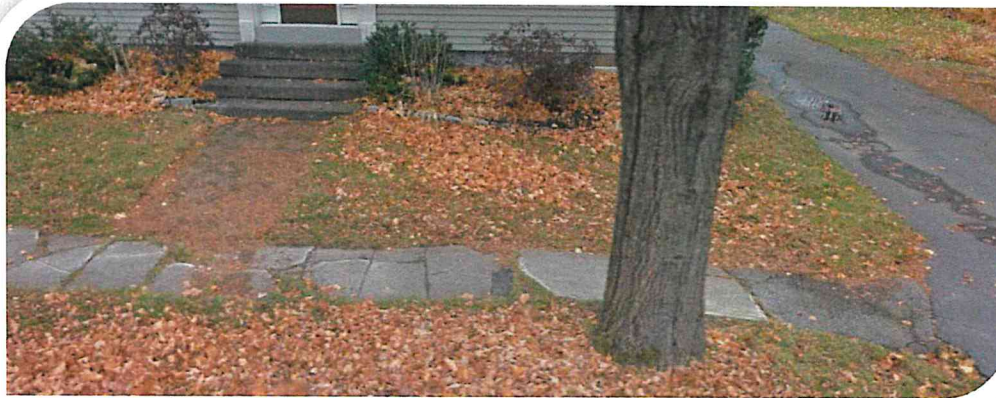
Figure 3.8: An example of a sidewalk that would receive a “Poor” rating.

A sidewalk with a poor rating exhibits significant issues with its condition that would give most users, especially users with mobility issues, difficulty in use. The sidewalk would have clear signs of cracking, spalling, gaps, or rises that would affect the freedom of movement for users. An example of a sidewalk in poor condition would be Green Street in Gorham. This sidewalk would be difficult to use for most users, in this case clearly showing major cracks or missing sections, spalling of the sidewalk material, gaps between sidewalk segments, and rises between segments which may pose a tripping hazard. This segment also is narrower than 5’ wide. A narrow sidewalk can create issues for mobility and are more prone to obstructions in access.

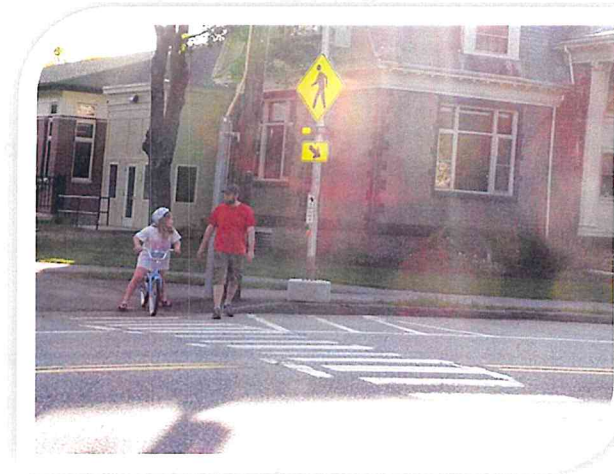
Figure 3.11 School-aged child crossing at the South Street mid-block crossing between the library and school route.

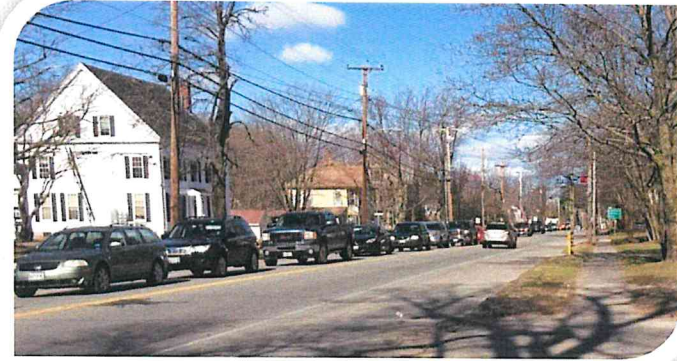
Figure 3.13: Westbound vehicular traffic on Main Street / Route 25 builds up during the evening commute hour as people head towards the Gorham Village Area

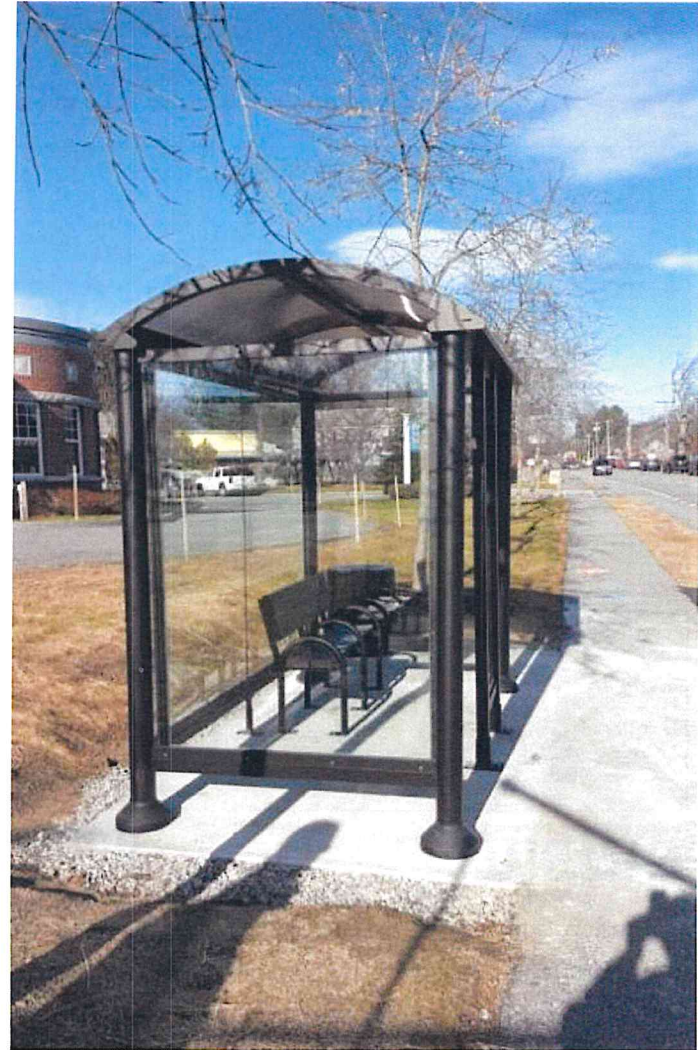
Figure 3.16: Example of a METRO bus stop complete with Bus Shelter

There are currently two stops planned for the Town of Gorham in the bus route's first implementation phase. One stop will be placed within the University of Southern Maine's Gorham Campus, and the other will be located at the intersection of Main Street and Water Street / Elm Street. Bus stops will be located on both sides of the road, with the Southern stop serving eastbound traffic out of Gorham and the northern stop serving westbound traffic into Gorham. Staff at METRO are also considering another stop for the Town of Gorham if the service warrants it. This stop would be in proximity to the intersection of Main Street and Chick Drive. Stops will include bus shelters, route information, and other basic amenities (see Figure 3.16). METRO has also stated that there is potential for bicycle racks to be placed at stops.

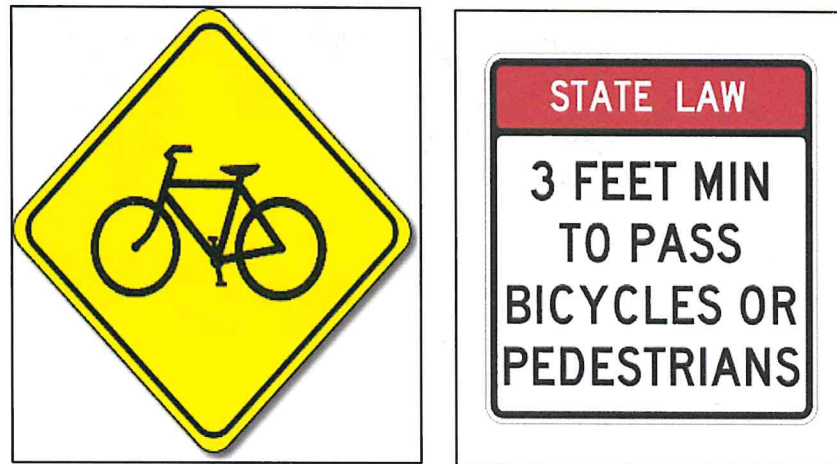
Figure 4.3 (Left) and 4.4 (Right): LEFT - Maine DOT Bicycle Signage - W11-1; RIGHT - MaineDOT "3 feet min. to pass" signage

- * Along Main Street / Route 25 from New Portland Road to School Street / South Street it is recommended that the width of the center turn lane be 11 feet and that shared lane markings (a/k/a sharrows) and MaineDOT signage (The "3-feet min. to pass" signs shown in Figure 4.4) be implemented. Access management should also be implemented here.

Signing and striping changes are recommended as measures to integrate bicycle facilities safely into the travel-way and reduce traffic speeds. The existing pavement can be repurposed by narrowing travel lanes to 11 feet to allow for installation of a 2-foot buffer strip between the travel lane and a new bike-friendly shoulder measuring a minimum of 5 feet wide. The lane should be marked accordingly with bike lane stencils and Supplemental bike signage should be installed, as shown in Figures 4.3 and 4.4 below.

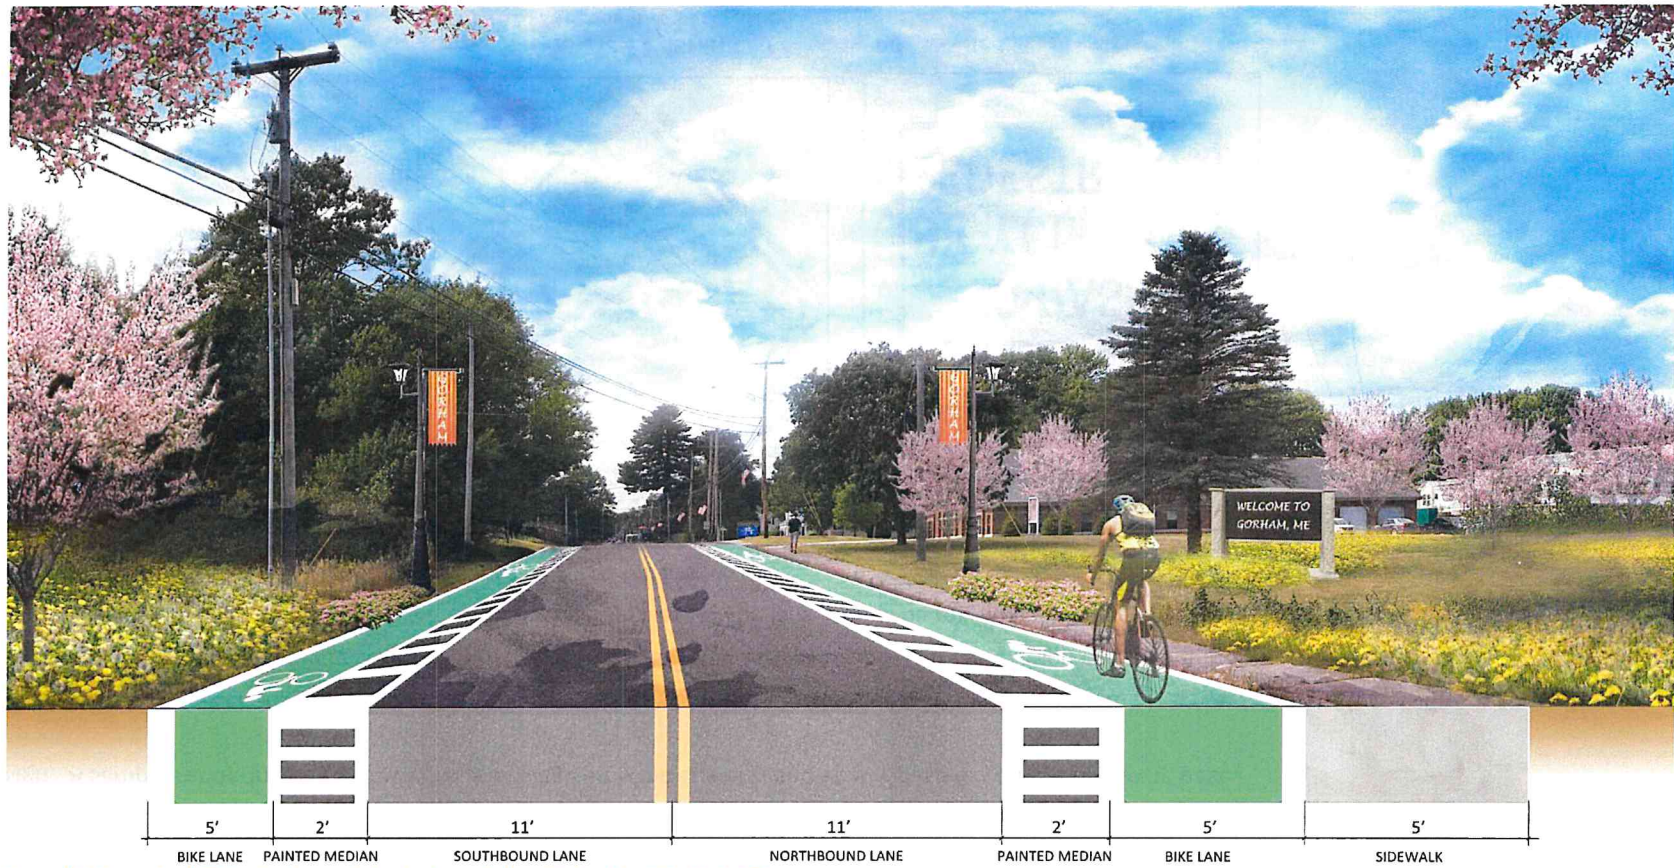
Figure 4.5: Example of Gateway signage to be implemented on each major entry to the Town.

- * Gateway treatments are recommended for each of the Town of Gorham's main roadway approaches. This signage will serve as a reminder to drivers that they are now entering a Town and that they should expect to see pedestrians and bicyclists.

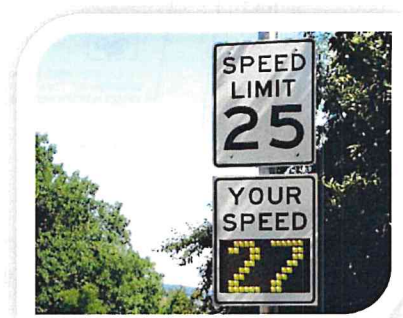
Figure 4.6: Speed Radar Feedback Signage

After crossing Route 114, Route 25 changes names to State Street. The area between Route 114 and the intersection of State Street and Narragansett Street quickly turns more residential and less commercial. Recommendations on this stretch of Route 25 include gateway signage like that described for westbound traffic into town. Since traffic eastbound will likely be somewhat faster, speed radar feedback signage (shown in Figure 4.6) is recommended as well to reinforce the change in context from arterial to village setting. This section of road should also feature 11-foot-wide travel lanes and available shoulder width would dictate use of sharrows and signage. Pedestrian- and bicyclist-level wayfinding signage is also suggested at the approach to Route 114.

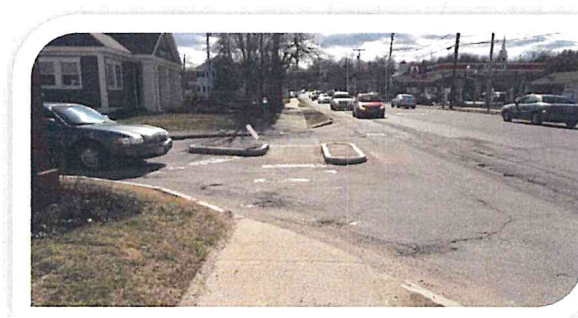
Figure 4.7: Segment 3 includes many potential pedestrian and vehicular conflicts due the many driveways.

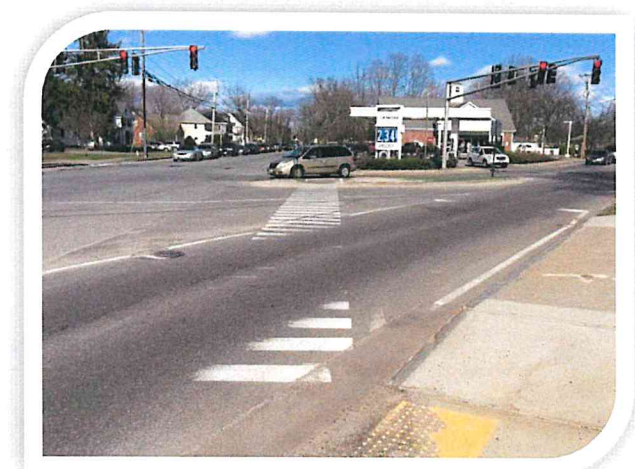
Figure 4.10: Intersection B: Main Street / State Street at New Portland Road

- * A significant geometric improvement is recommended for the intersection of New Portland Road and Main Street / Route 25. This includes reducing the intersection footprint and introducing smaller radii to reduce speeds and shorten pedestrian crossing distances. The signal would be upgraded to add a new pedestrian phase and signal equipment upgrades for full ADA compliance. A new high visibility crosswalk would be installed along with improved sidewalk connections.

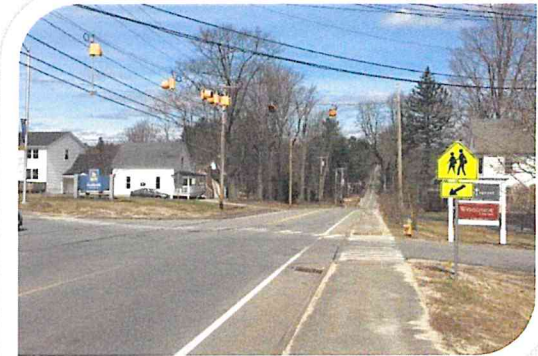
Figure 4.15: Intersection A - School Street / South Street at Campus Avenue intersection with overhead flashing

As School Street moves north away from the Gorham Village Center, traffic tends to speed up. The School Street at Campus Avenue Intersection ranked #3 for pedestrian/walking concerns in the Outreach Survey due to visibility and safety concerns crossing Route 114. The intersection includes overhead flashing signals, but their effectiveness is minimized because they are not user-activated, but rather flash constantly (see Figure 4.15). The signal equipment may have been installed as a warning to northbound traffic to ameliorate a potential visibility restriction.

The recommendations at this location focus on improving the safety of pedestrians crossing at this location. New high visibility crosswalks should be built in conjunction with a curb extension on the northwest corner of the intersection to shorten the pedestrian crossing and improve pedestrian visibility. In addition, the flashing beacons should be replaced with a more interactive treatment. The use of an RRFB would be consistent with their use elsewhere within the village, although signal visibility for northbound vehicles would need to be field tested. Vertical extension of the RRFB is one possible solution. The installation of a high intensity activated crosswalk device, commonly known as a HAWK signal, offers another solution. Because it is newer technology, the HAWK signal is not an accepted device by MaineDOT. However, its use could be pursued with them at this location. The advantage of HAWK is the higher vertical placement of the signal indications. A HAWK signal installation is shown in Figure 4.16.

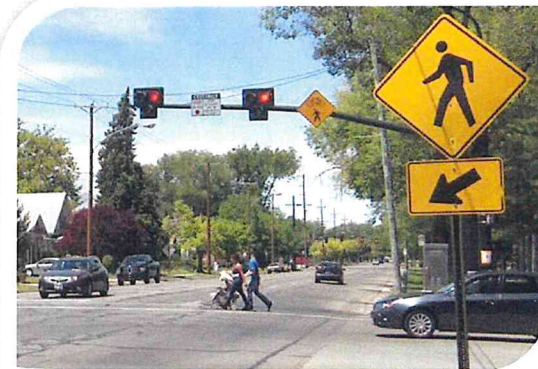
Figure 4.16: Hawk Signal, Photo Source: NACTO.

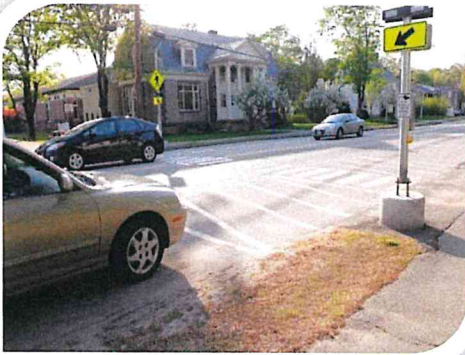
Figure 4.17: Intersection C - Street / South Street at Library (Mid-Block Crossing)

Recently redesigned, this mid-block crossing includes an RRFB, a crosswalk and high visibility signage (see Figure 4.17). However, the proximity of parked cars to the intersection obstructs the views between motorists and pedestrians. It is a key crossing area, leading pedestrians between Town Hall and the high school to the west and the Village Elementary School and shopping areas to the east. When ranked in the Outreach Survey, this intersection was sixth for pedestrian/walking concerns (with only 9% choosing "Unsatisfied" or "Highly Unsatisfied") and fifth for bicycling concerns (with only 18% choosing "Unsatisfied" or "Highly Unsatisfied"). The recommendations to improve this mid-block crossing including curb extensions to mitigate the visibility constraints as well as replacing the existing white bar painted crosswalk with one constructed of high visibility materials.

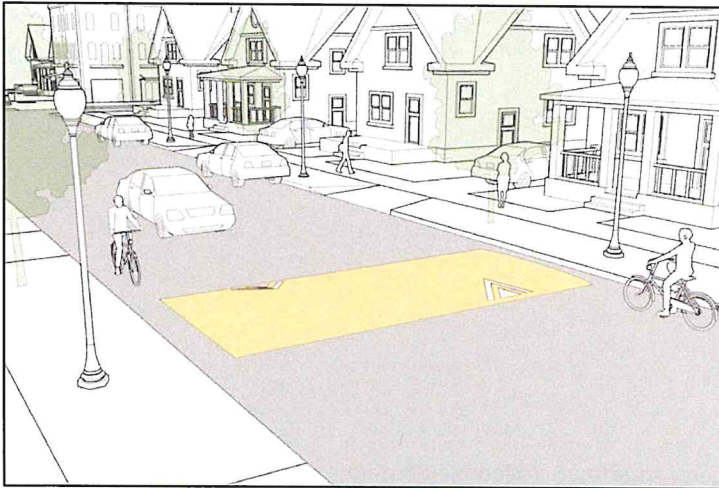
Figure 4.23: Speed Table Traffic Calming Treatment, Photo Source: NACTO

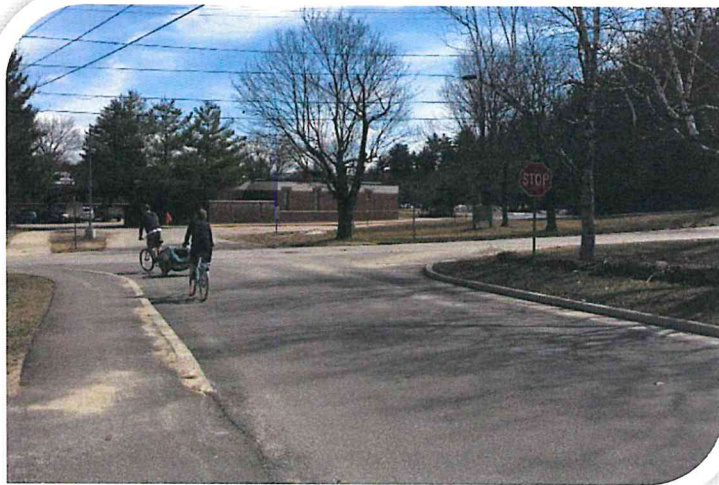
Figure 4.24: Segment 4 – Lincoln Street from South Street to Robie Street

Another important access point to the Village Elementary School, Lincoln Street currently has a sidewalk on the north side. But due to a lack of separation from vehicular traffic, it is perceived as uncomfortable (see Figure 4.24 on the previous page). Recommendations to address concerns, calm traffic, and minimize the use of Lincoln Street as a cut through are as follows:

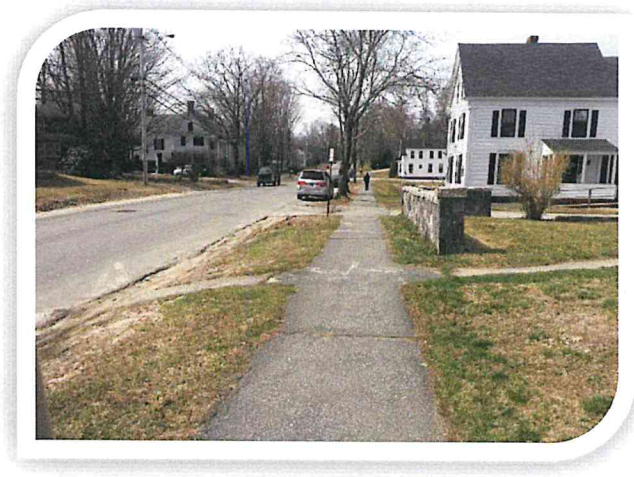
Figure 4.27: Segment 2 – College Avenue from School Street to State Street

This road provides access to the University of Southern Maine from the heart of Gorham Village. Currently, there sidewalks are limited to the north side of the street. Very wide vehicular lanes in this area contribute to vehicular speeding. To address these issues, offset the roadway centerline pavement marking and add a shoulder line on the south side of the road to provide a narrower travel way and traffic calming (see Figure 4.27).
